Further description of listed complaints.

1. I worked with AZ Solar Living (the Contractor) on a layout that would mitigate shade as much as possible and after several configurations, we agreed on the attached layout. This layout also properly followed the necessary Fire Dept. setback rules for solar PV installs.

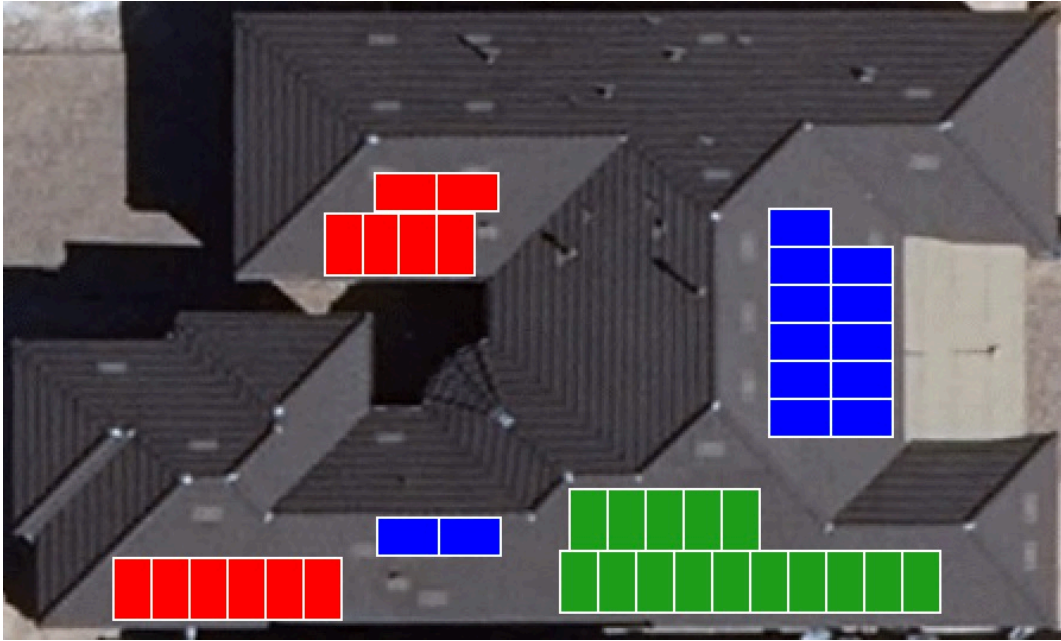
Once the install of the roof mounts and racking was actually completed by the Contractor, they were placed in a way that the layout of the panels would have not followed the agreed on design, the permit, or the fire code setback.

I advised the Contractor that I did not feel the mounts and racking were installed correctly and that they did not meet the required fire setback code and was told "It will be fine".

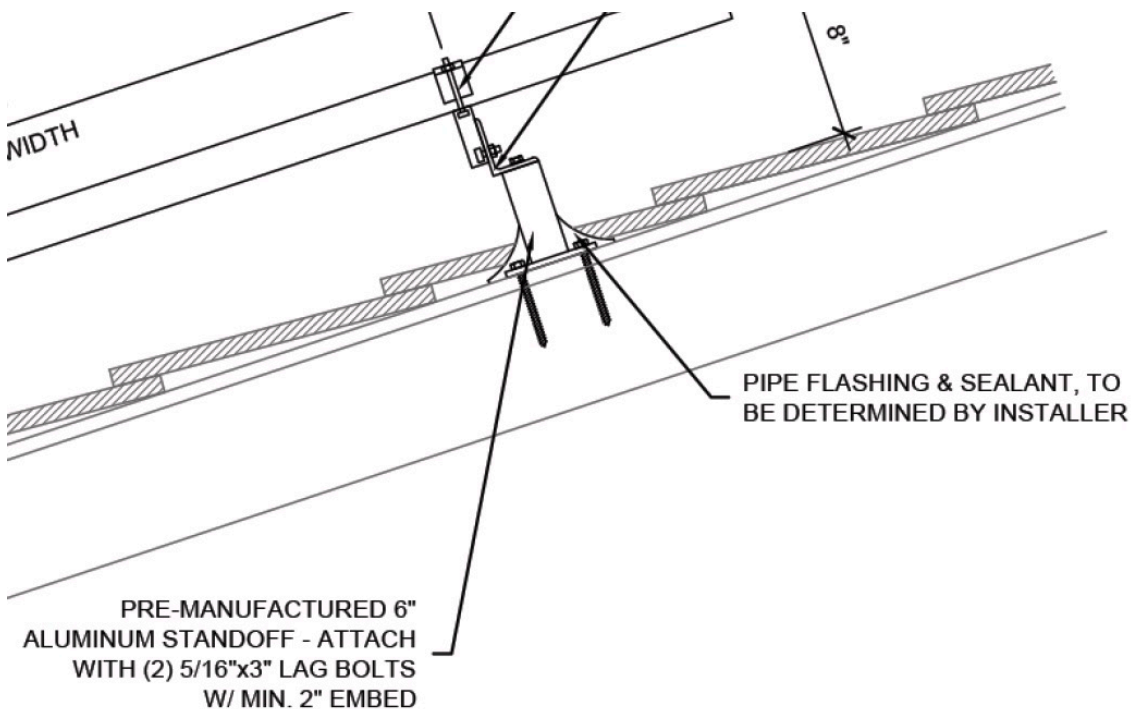
This is what the permit specified:

2. The Contractor used zinc coated hanger bolts for the installation of the solar racking mounts. The permit specified pre-manufactured 6" aluminum standoffs attached with (2) lag bolts. I specifically asked the Contractor to send me a copy of the permit prior to submitting it to the city to make sure we were "on the same page" as to how and what was being installed and fully expected the mounts to match the permit submitted and approved. I brought up the issue with the Contractor upon seeing the hanger bolts and was told the permit showed just a "generic" model and that it did not have to match exactly. I placed a call to the City of Peoria and was advised that information is not correct and that the mounts do in fact have to visually match the permit and be rated for the wind and load bearing specified on the permit.

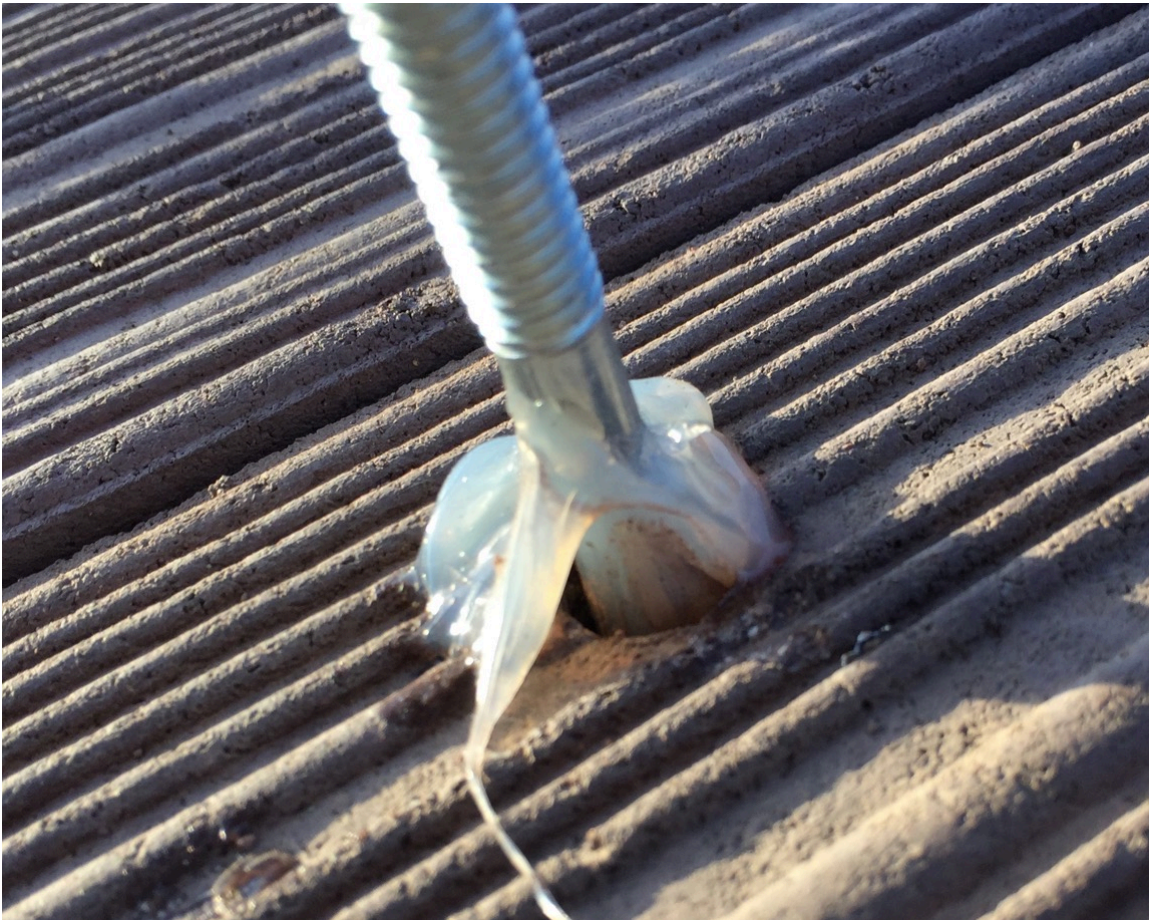
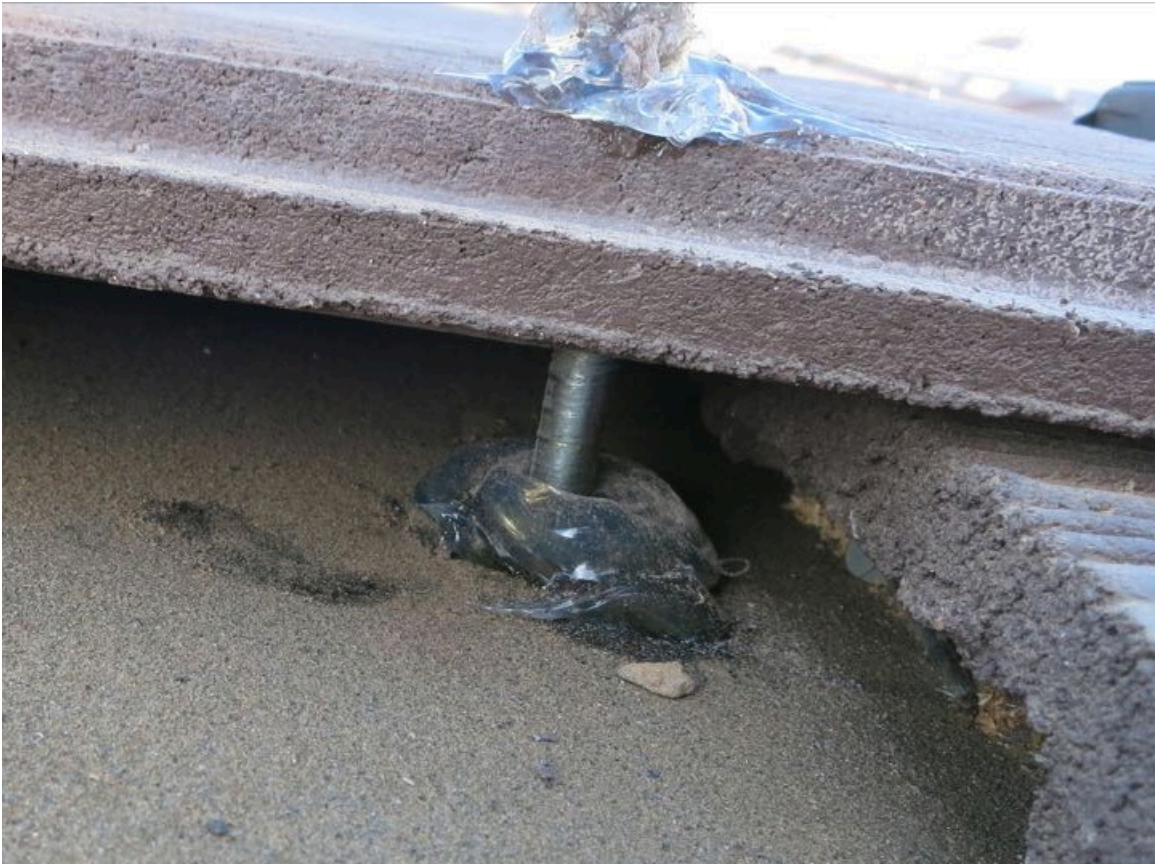
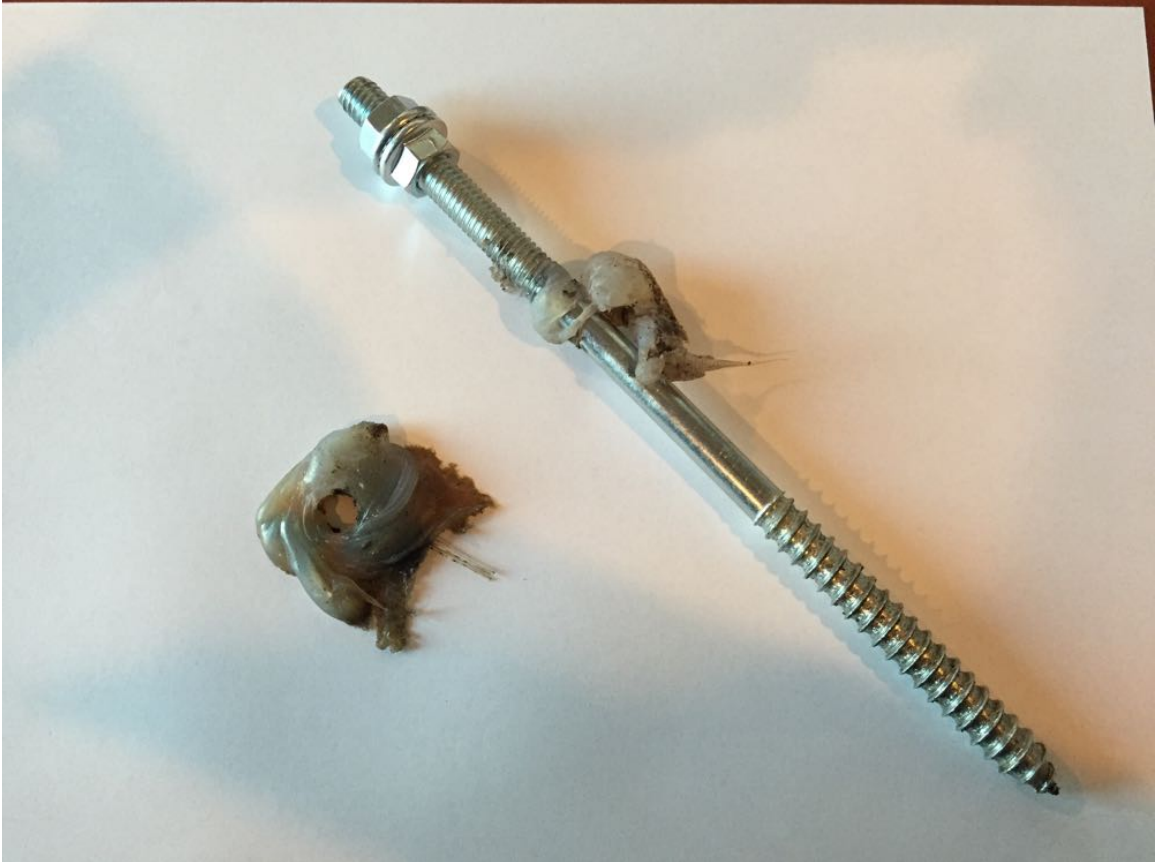
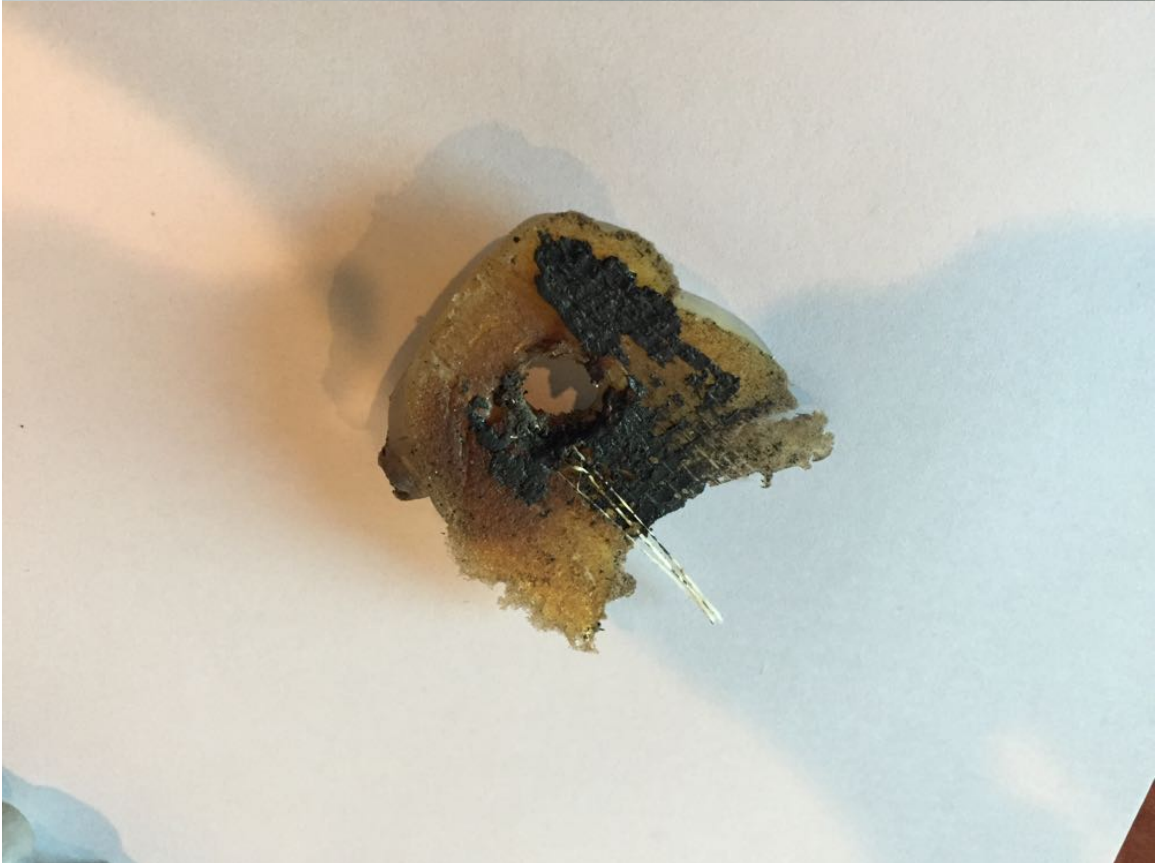
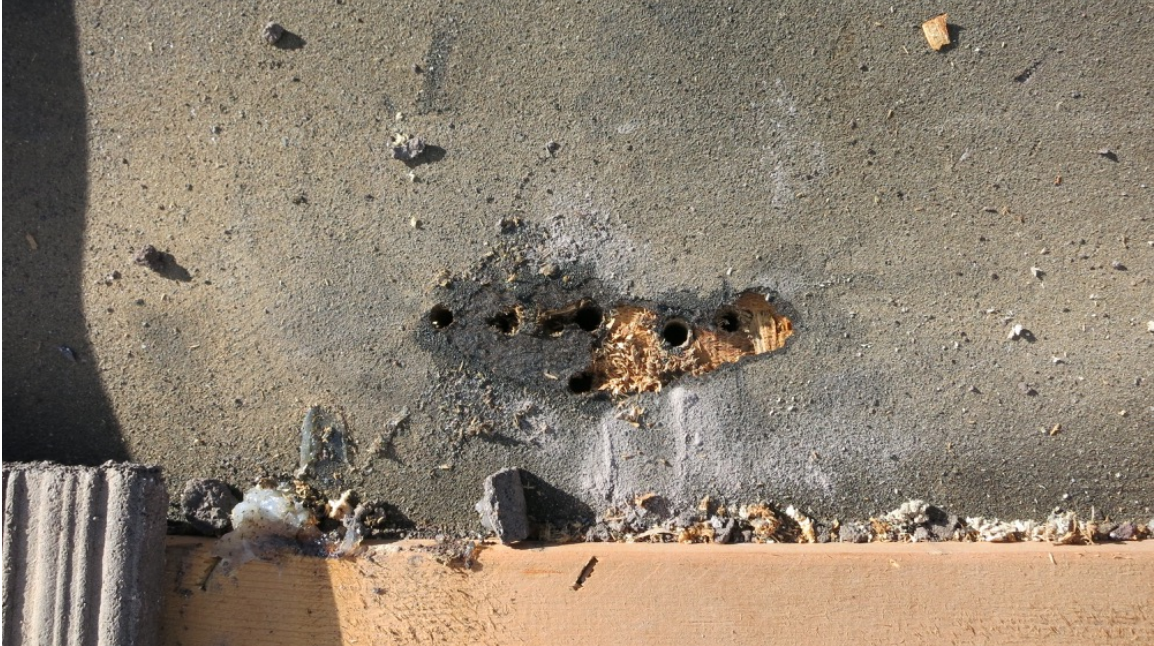
3. Contractor installed the improper roof mounts (hanger bolts) by drilling through the flat roof tile and into the roof rafters and applied silicon as a sealant on top of the tile and on top of the underlayment. I contacted several roofing companies to confirm if this is an acceptable roofing method and all of them said it was incorrect, not to code and not to acceptable standards. I was advised by the roofing companies that the silicon sealant would last at most a couple of years under the Arizona sun and the penetrations would most definitely leak.

In addition, upon inspecting the work myself, I found several penetrations that the Contractor did end up not using (did not install a hanger bolt at that location) which some were filled with silicon sealant while others were not and were left free to leak.

I attempted multiple times to contact the Contractor about having the work redone. He initially said on 12/15/14 he would not redo the work. On 12/16/14 we came to an understanding that I would purchase the correct mounts and he would come and install them. At this time the Contractor stopped communicating and did not return calls or text messages. Needing the project completed and not hearing back from the Contractor I started to redo the roof work myself. I was advised by the Contractor's office on 12/29 that the Contractor had left on vacation and was returning on 01/05. The Contractor finally contacted me again on 12/31/14 after I called his office and advised them I would be cancelling the installation and having the payments made to him reversed.

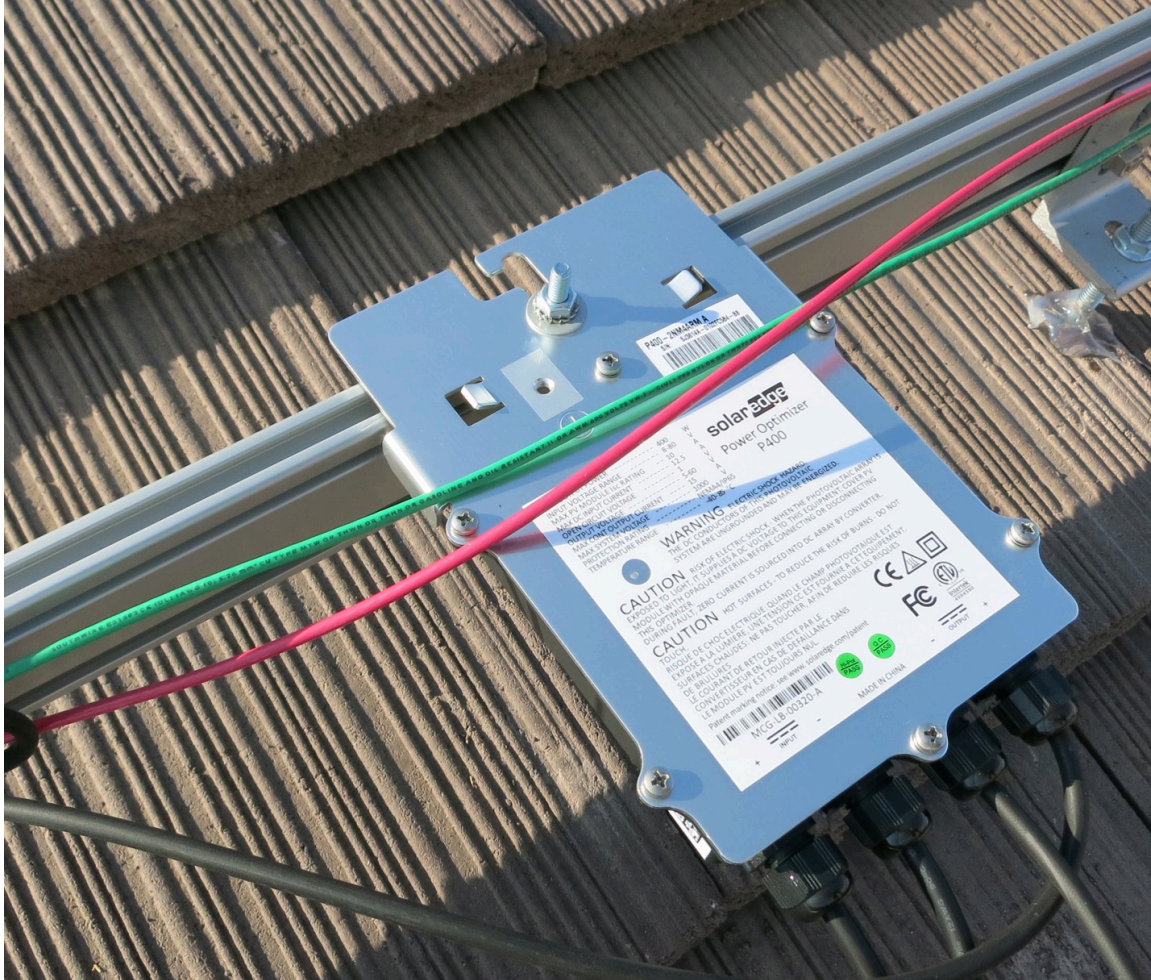
4. Contractor installed type THWN on the roof for the wiring between solar arrays, which is not rated for outdoor use and must be installed in conduit. The permit specified USE-2 wire, which is rated for outdoor use.

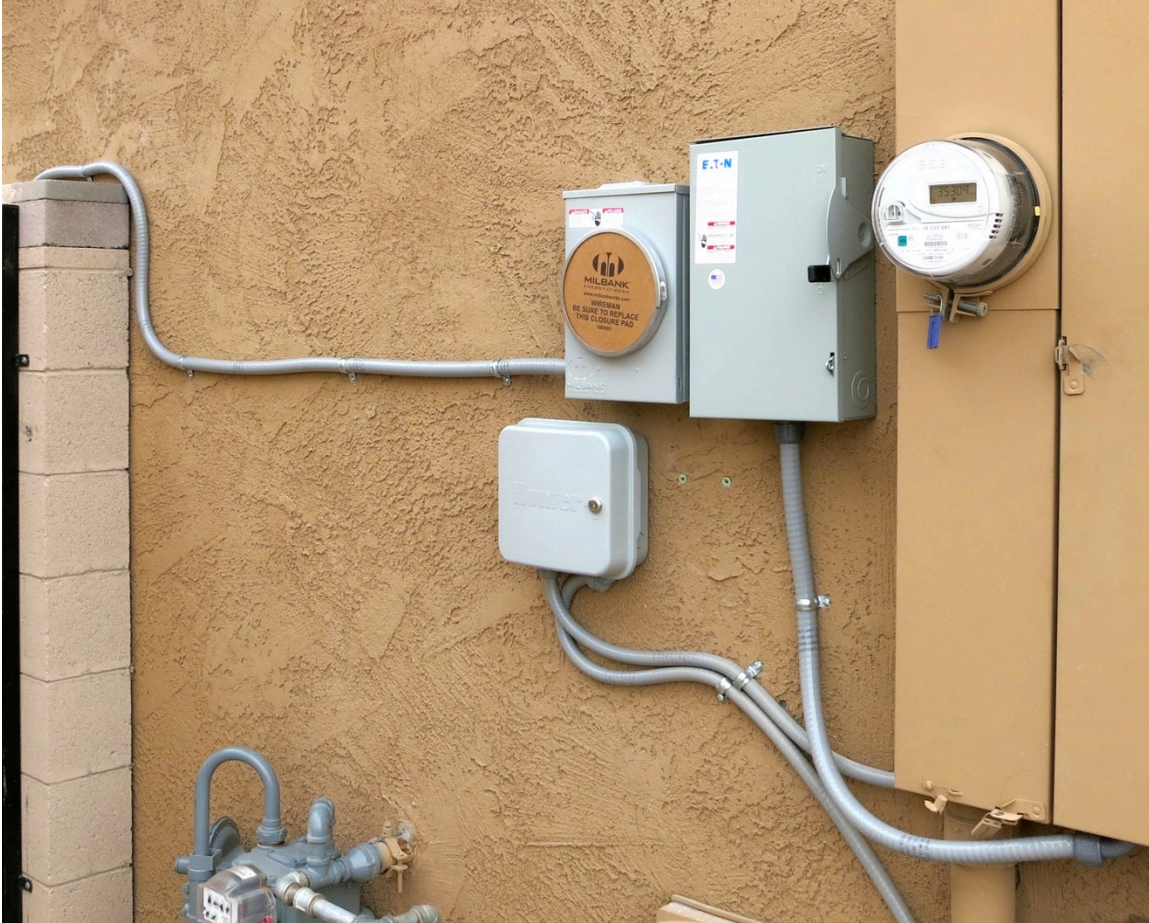
5. Contractor installed $\frac{3}{4}$ " liquid tight plastic conduit between the SES and solar inverter. The permit specified 1" EMT.

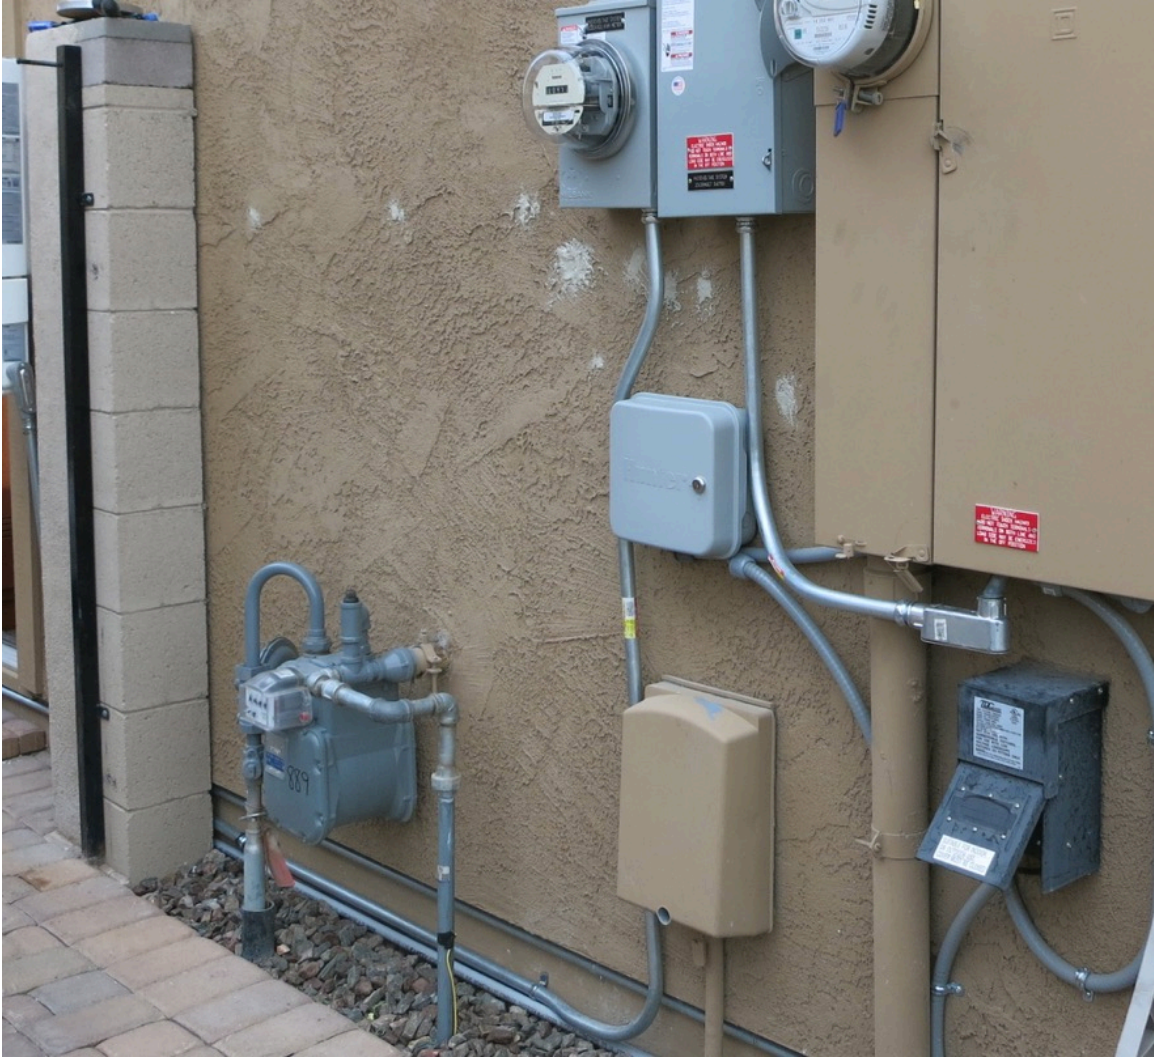
6. I advised the contractor that the plastic liquid tight conduit is not acceptable, both per the permit and aesthetically. The contractor replaced the plastic conduit with EMT, however the incorrect size was again used and did not match the specifications of the permit. This was one of the main points of why the project failed city inspection.

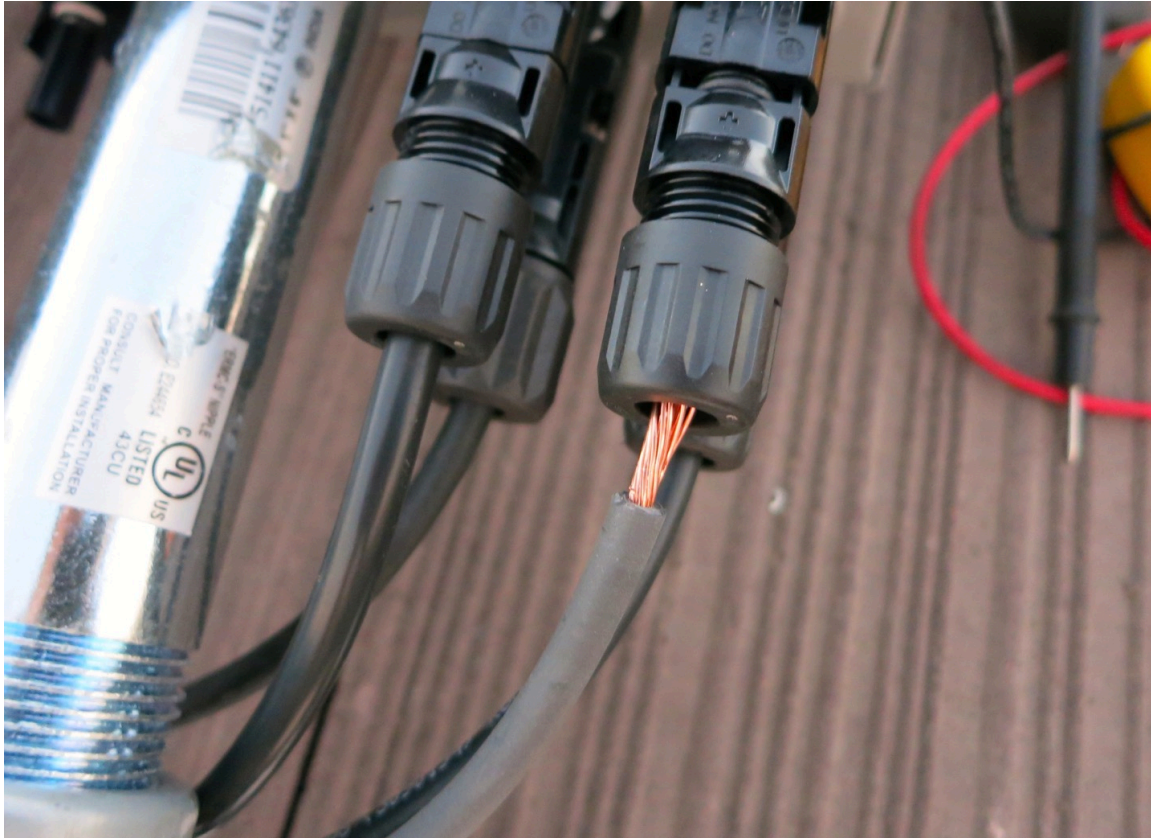
8. Several connections to the MC4 connectors on the roof were discovered to be loose. The contractor used plier to crimp the connections instead of the proper MC4 crimping tool.
